Surgical management of peri-implantitis with laser

A Case Report with eight years follow up

Authors Prof. Dr Aslan Yağar Gokbuget, Emin Selim Pamuk, Res. Asst. Dt. Necla Aslı Kocak, Turkey

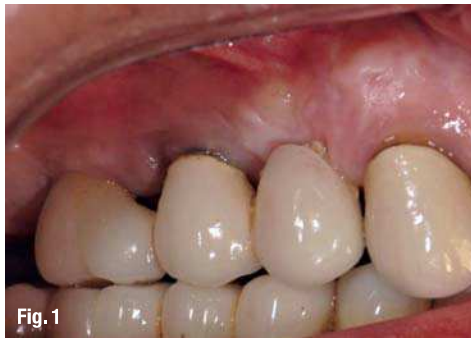
Fig. 1

Fig. 1_First examination.
Fig. 2_After removal of the dental prosthesis.
Fig. 3_Probing depth around implants.

A 60-year-old female patient presented at our private clinic PGG for treatment of the implants at the right maxillary molar site. The implant has been placed seven years ago and the implant supported simulated porcelain fused to metal fixed partial denture was made (Fig. 1). Upon review of her medical history she was otherwise healthy. She previously had been treated for chronic periodontitis with non-surgical approach. Then radiographic examination was made and revealed a combined marginal and vertical radiolucency. The implant crown was removed (Fig. 2) and on clinical examination deep probing depths were isolated (Fig. 3). No clinically detectable mobility of the fixture was present. The patient was referred for an extra implant on the right first premolar site while doing a surgical entry for the peri-implantitis around the two implant at the right maxillary molar site. One hour prior to surgery, the patient was given 2 g of Amoxicillin and following surgery placed on a regimen of Amoxicillin 1,000 mg tid for 5 days post-op. A crestal incision is scalloped around the implant neck to eliminate the internal epithelium and granulation tissue from the pocket. A mucoperiosteal flap is raised to expose the implants (Fig. 4), and bone tissue and granulation tissue is eliminated from the bone defect with Er:YAG laser with power settings of VSP 120 mJ, 10 Hz with water and air flushing and Nd:Yag laser with 300 µm tip, VSP, 2Hz, 20 W power setting is used for implant surface detoxification. An additional 3.3 x 13 mm TSW implant was placed to first premolar site, then Xenogenous bone grafts (Bio-Oss®) compacted into the defect. A non-resorbable Gore-Tex® barrier was placed over the defect and was extended buccally and lingually. The buccal and lingual flaps were released and tension-free primary closure was achieved with 4-0 teflon sutures. She was instructed to continue the antibiotics as prescribed and to rinse with the 0.12% Chlorhexidine gluconate bid for one minute, twice a day. Finally, a strict maintenance and oral hygiene protocol were established.
